INSTRUCTIONS

Kit Number 57800-00

FAIRING BRA

This kit is designed for installation on 1996 and later FLHT, FLHTC, FLHTCU AND FLHTCU/I Model Motorcycles.

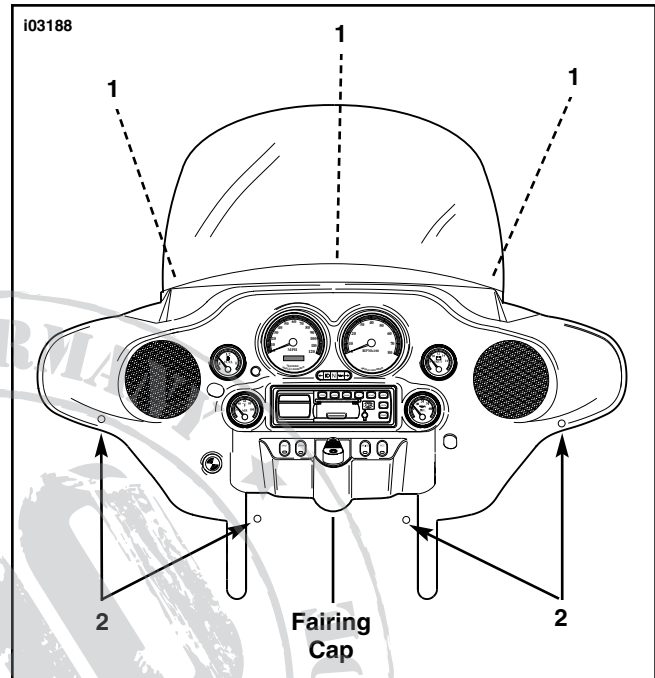
Figure 1. Windshield and Fairing Hardware

1. Align each of the sewn-in pockets on the fairing bra with each of the outer edges of the fairing at handlebar level.
2. See Figure 1. Standing in front of the vehicle, remove the three T27 Torx screws (1) with washers securing the windshield along the front of the fairing.

4. The six straps (three on each side near the bottom) will be captured between the inner and outer fairing. Refer to Figure 1. Remove the four screws (2) from the inner fairing. **NOTE:** The bottom two screws are below the fairing cap. Save screws for installation. Separate the inner and outer fairings just enough to install the straps into the fairing. Adjust the straps, then reinstall the screws and tighten securely.

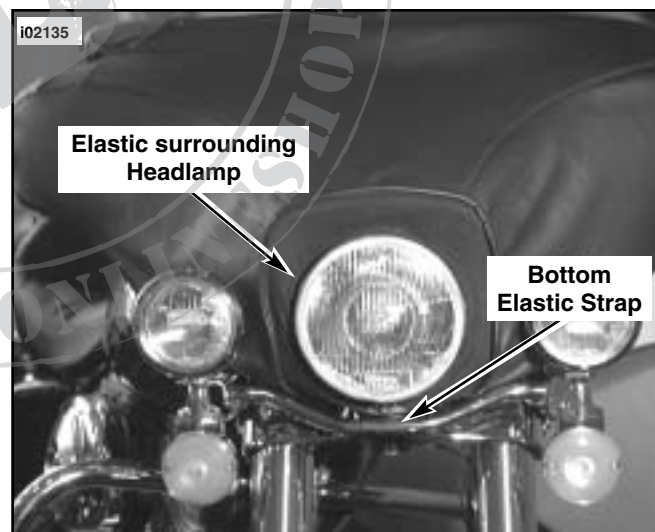
Figure 2. Proper Orientation of Fairing Bra (Headlamp Trim Ring Not Installed)

5. Remove the Phillips screw located at the bottom of the headlamp trim ring. Save screw for installation
6. See Figure 2. Orient the elastic portion of the bra around the headlamp, however in front of, the retaining ring as shown.
